Service Bulletin

SAFETY RECALL

2006-2012 GL1800-8A AIRBAG MODULE REPLACEMENT

Phase 2; recall expanded to include certain additional vehicles and remedy parts.

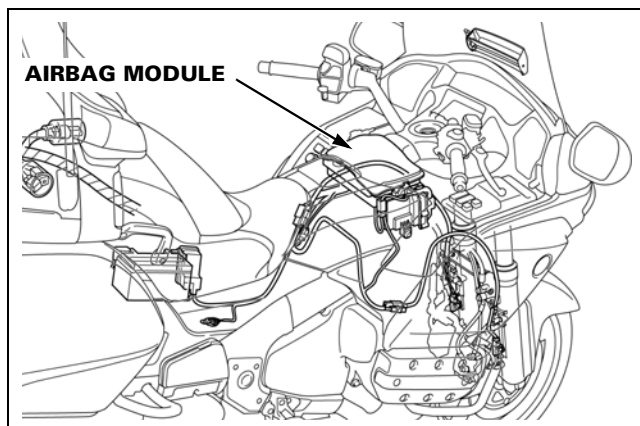
According to National Highway Traffic Safety Administration (NHTSA) equipment defect notifications (16E-042 and 16E-043) filed by Takata, the propellant in some of the subject inflators may degrade over time, which could lead to over-aggressive combustion in the event the airbag is activated during a crash. Overly aggressive combustion creates excessive internal pressure within the inflator, which may cause the inflator body to rupture upon deployment.

A redesigned airbag module is available to correct this condition.

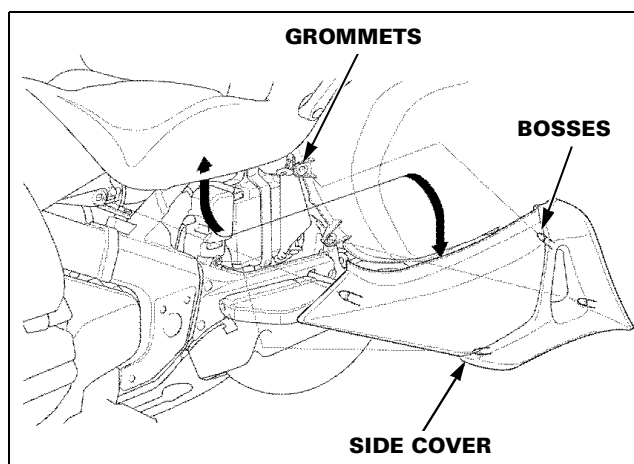
1. Turn the ignition switch to the OFF position.
2. Remove the left side cover by releasing the four bosses from the grommets as shown.

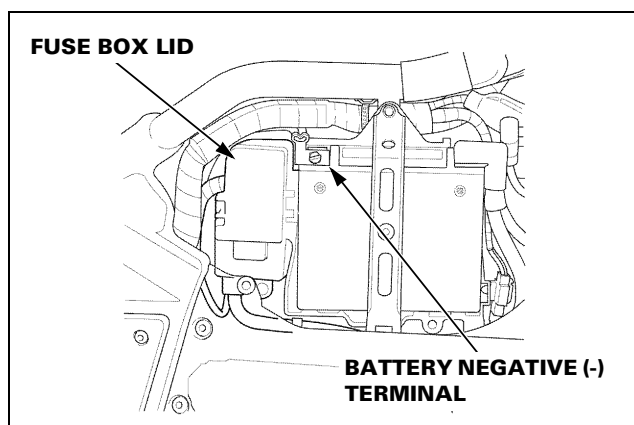
3. Disconnect the negative (-) battery terminal. Remove the fuse box lid.

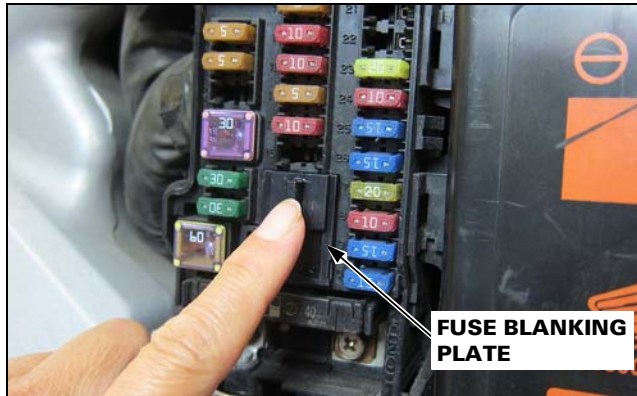
4. Check for a fuse blanking plate at the location shown.
 - If there is a fuse blanking plate, remove it with pliers and proceed to Step 4.
 - If there is no fuse blanking plate, the airbag system has not been deactivated, pro-

ceed to AIRBAG MODULE REPLACEMENT.

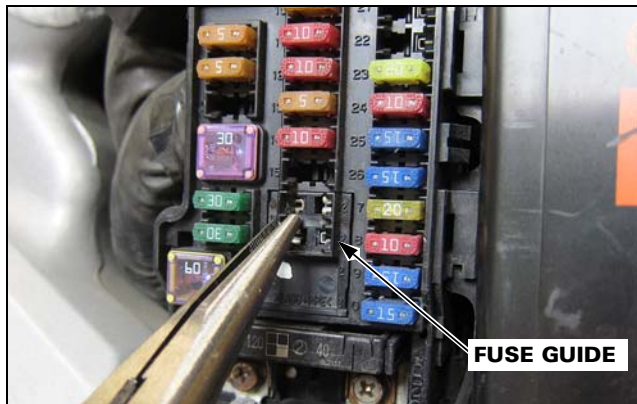
5. Install the fuse guide (supplied in the Update Airbag Module Kit) with pliers as shown.

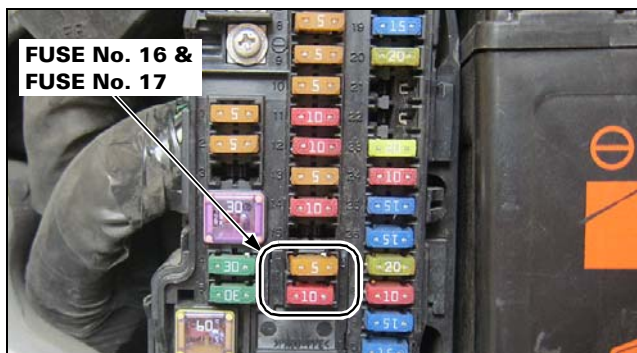
6. Install the No. 16 (5 A) and No. 17 (10 A) fuses (supplied in the Update Airbag Module Kit) into the fuse box.

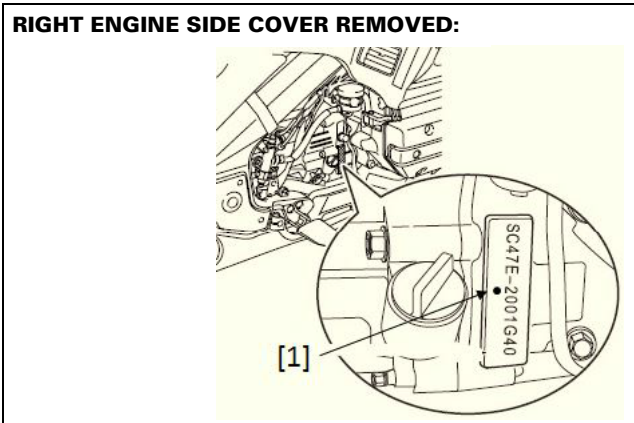
After the repair procedure is complete, apply a punch mark [1] under the first digit of the engine serial number, located on the right side of the engine.

Before you begin the Repair Procedure, check if the recall has been performed on the affected unit by looking for a punch mark on the **engine** as shown in the IDENTIFICATION section of this Service Bulletin.

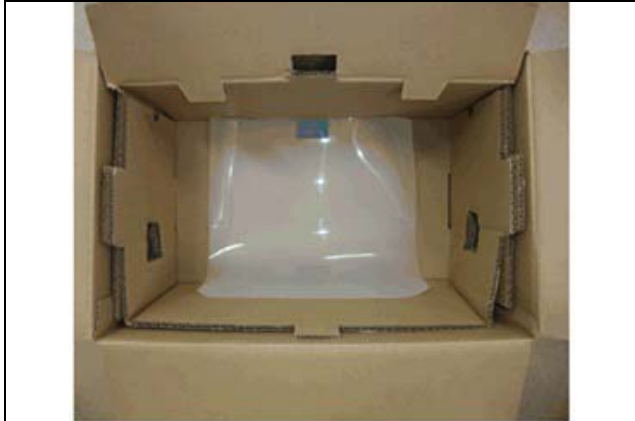
1. Place the plastic sheet at the bottom of the remedy part shipping box as shown.

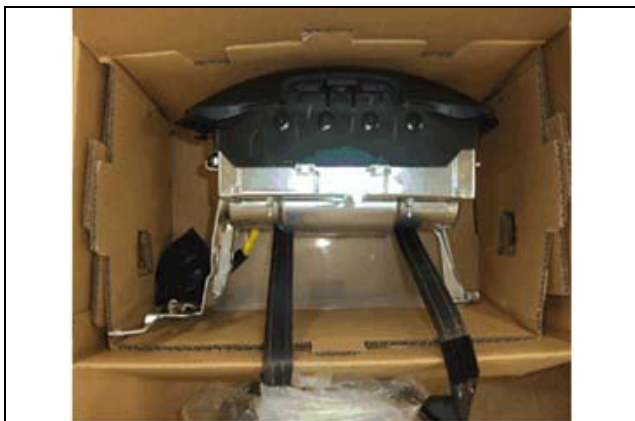
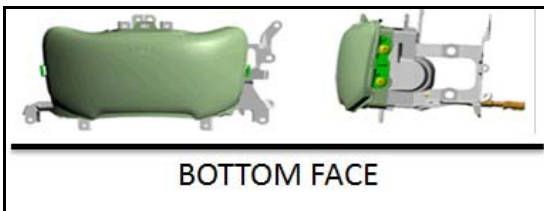
2. Place the recalled (undeployed) airbag module in the box in the orientation as shown, otherwise the box may break.

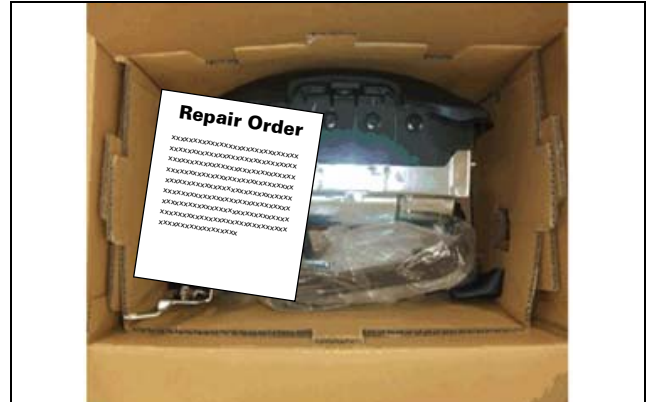
3. Put the metal fittings in the space left in the box.

Place a copy of the dealer repair order inside the box.

Seal the box with shipping tape.
